**CONCEPTUAL PLAN VIEW OF
STORMWATER DRAINAGE SYSTEM**

OPERABLE UNIT #2, VB 170 SUPERFUND SITE

EMSI Engineering Management Support, Inc.

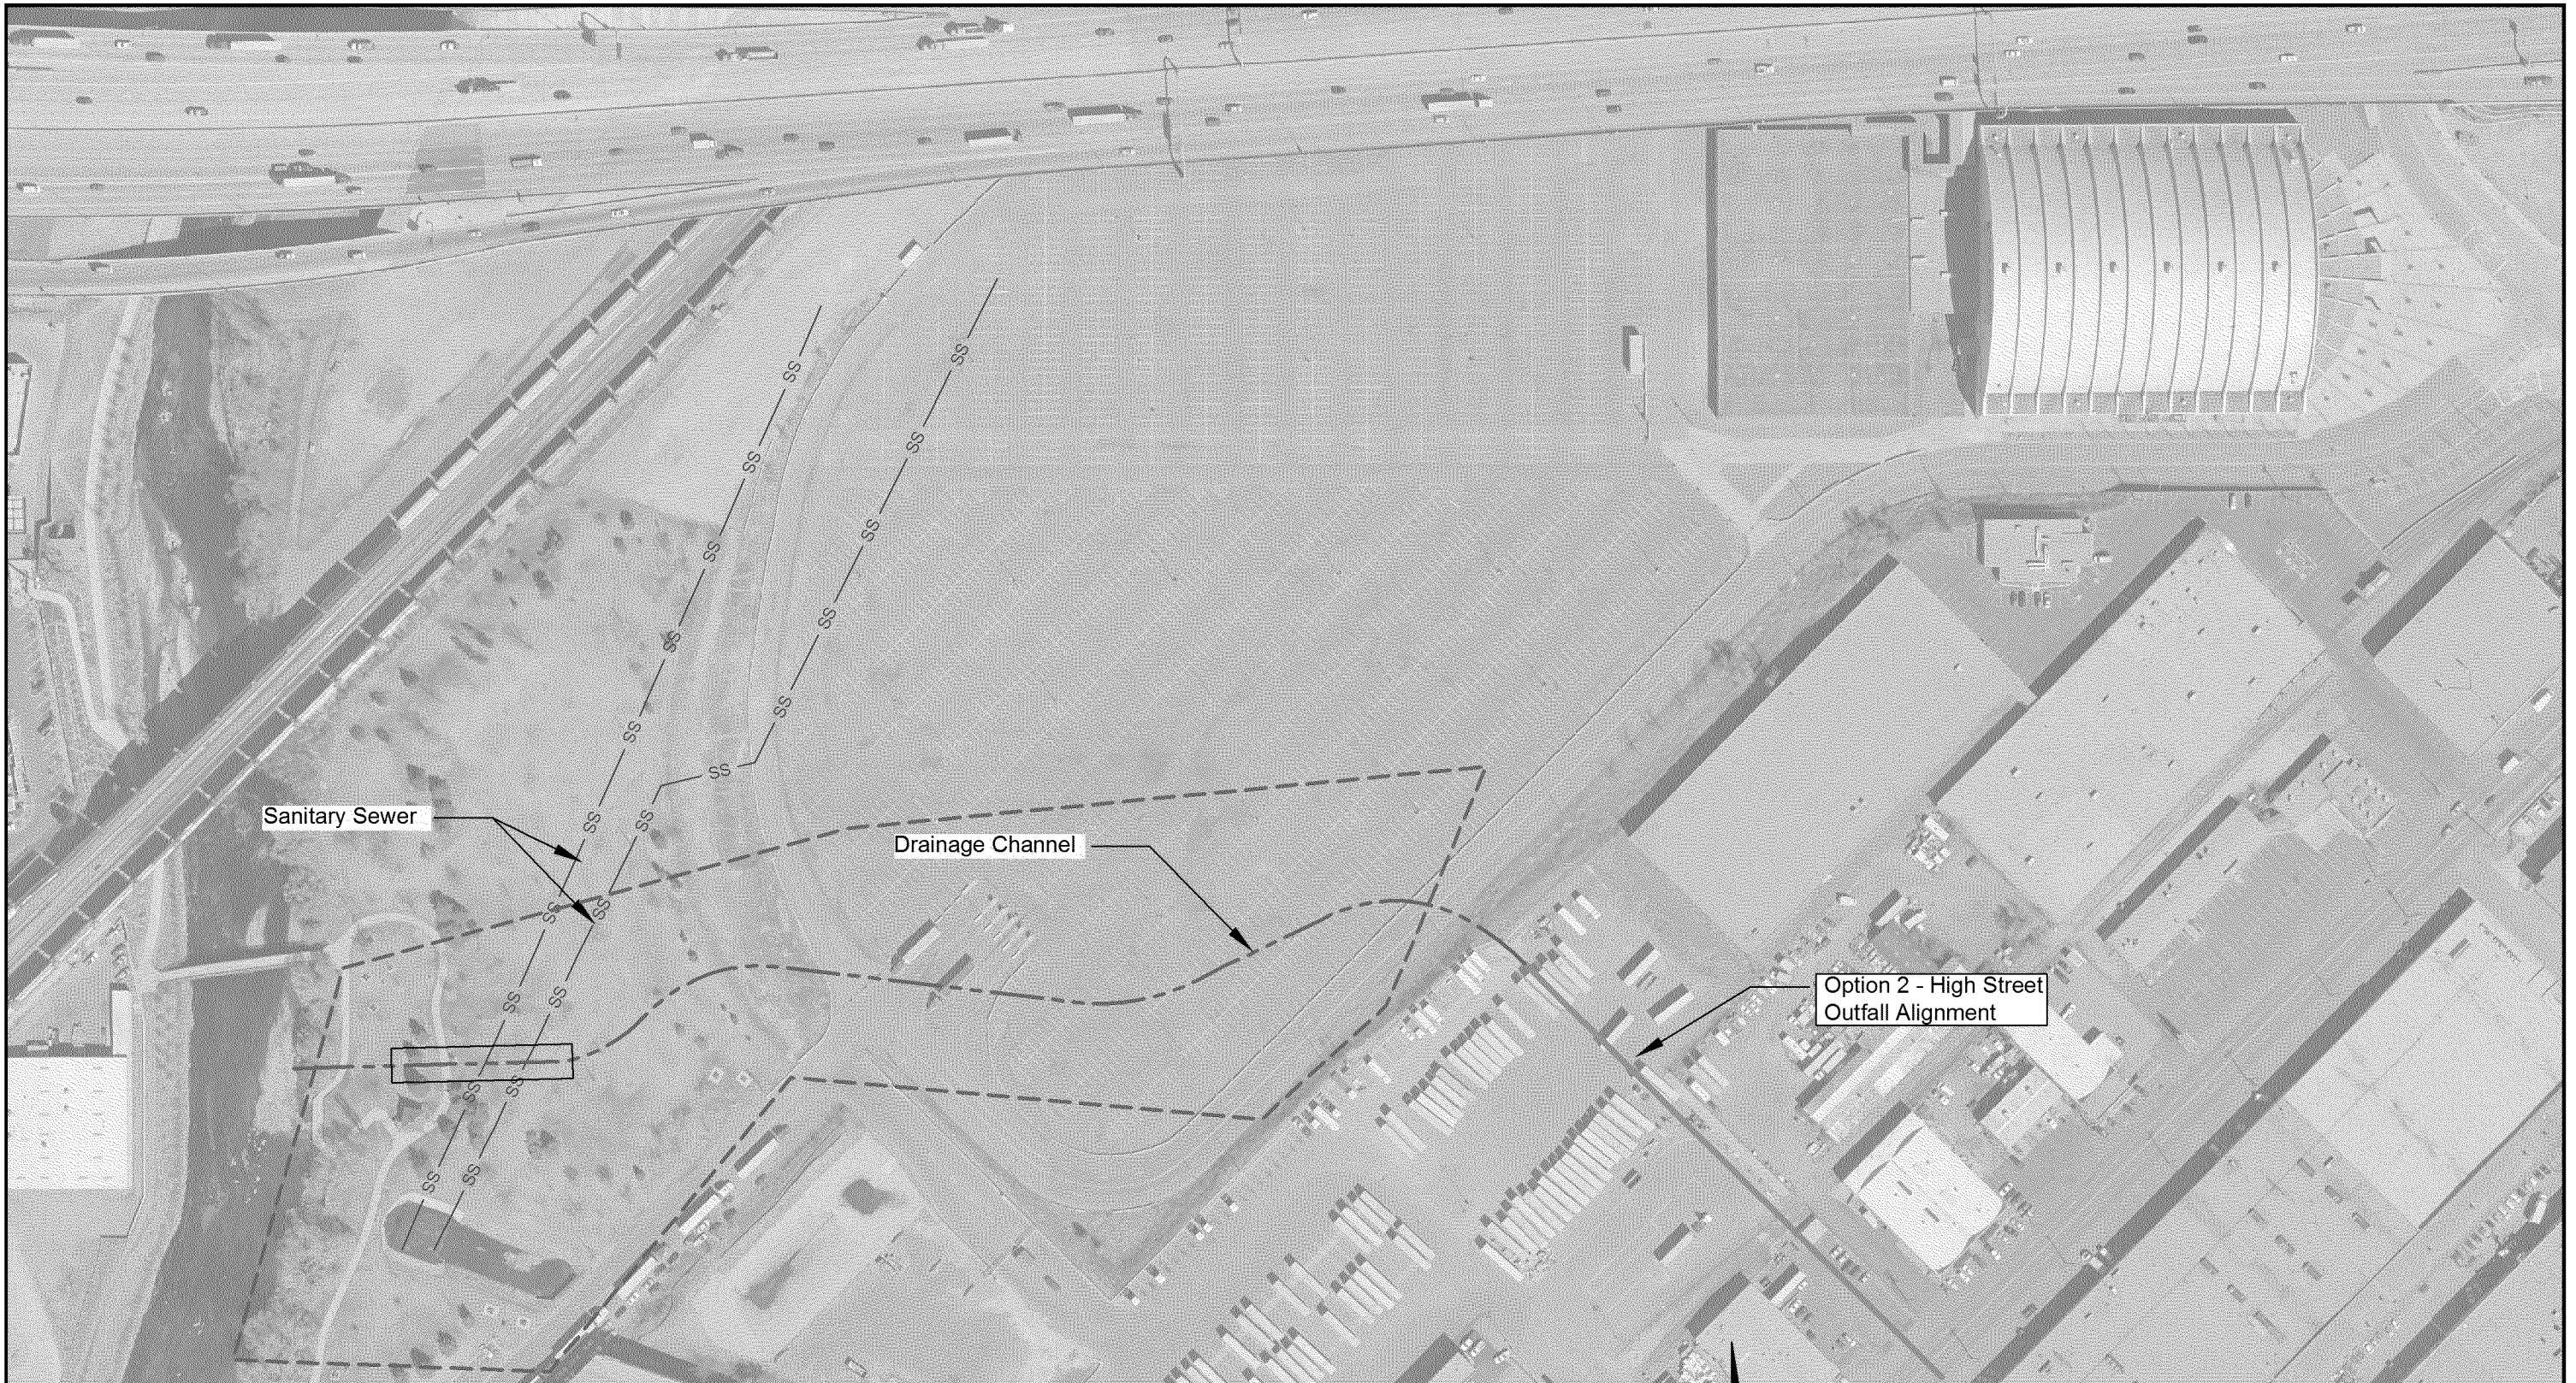
Figure 1

- Option 2 - High Street Outfall Alignment
- Drainage Channel Sampling Area
- Sanitary Sewer
